INDOOR AIR QUALITY ASSESSMENT

**Community Middle School
225 High Street
Randolph, Massachusetts**

Prepared by:
Massachusetts Department of Public Health
Bureau of Environmental Health
Indoor Air Quality Program
December 2019

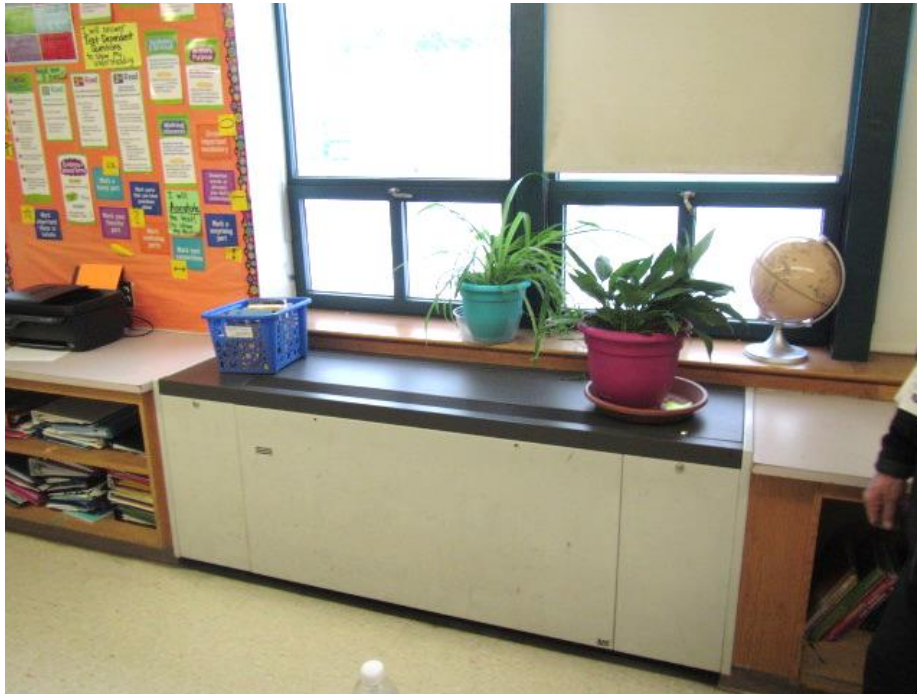
Picture 1

Fresh air in classrooms is supplied by unit ventilators (univents, Pictures 1 and 2). Univents draw air from the outdoors through a fresh air intake located on the exterior wall of the

Typical classroom univent, note plants on/near supply diffuser

1. Consider establishing a building-specific IAQ committee made up of teacher representatives, maintenance, facilities and administration to meet and conduct regular walk-throughs to identify on-going and/or potential issues.
2. Operate the HVAC system (supply/exhaust) to provide for *continuous* fresh air ventilation during occupied hours. Make repairs to thermostats, where possible, and to univents as needed.
3. If possible, restore a source of fresh/outside air in Room 282, either from the roof or from the adjacent Media Center.
4. Remove furniture and items blocking the front and top of univents.

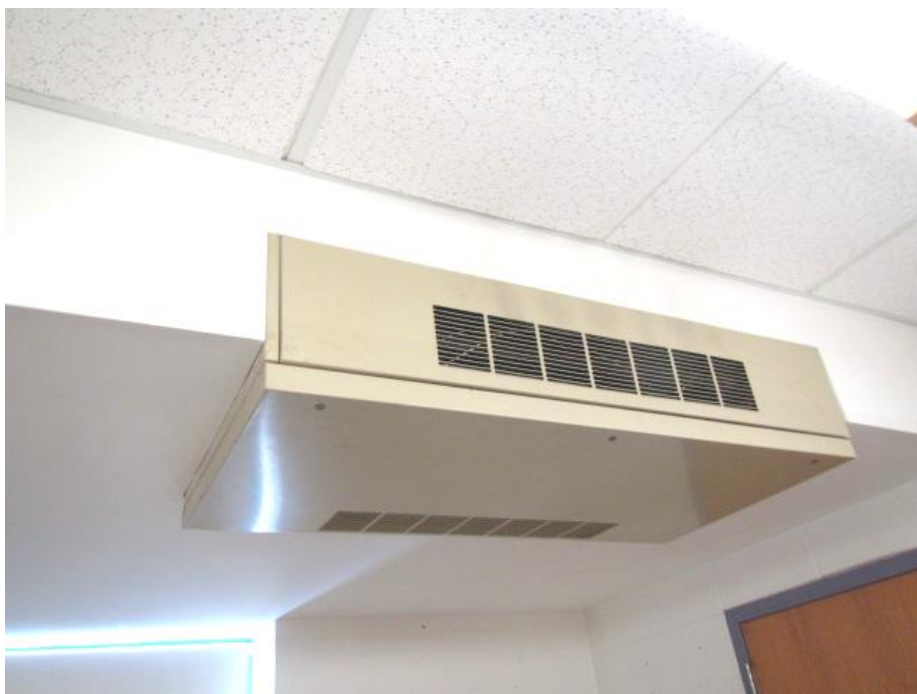
Picture 2

Ceiling-mounted univent

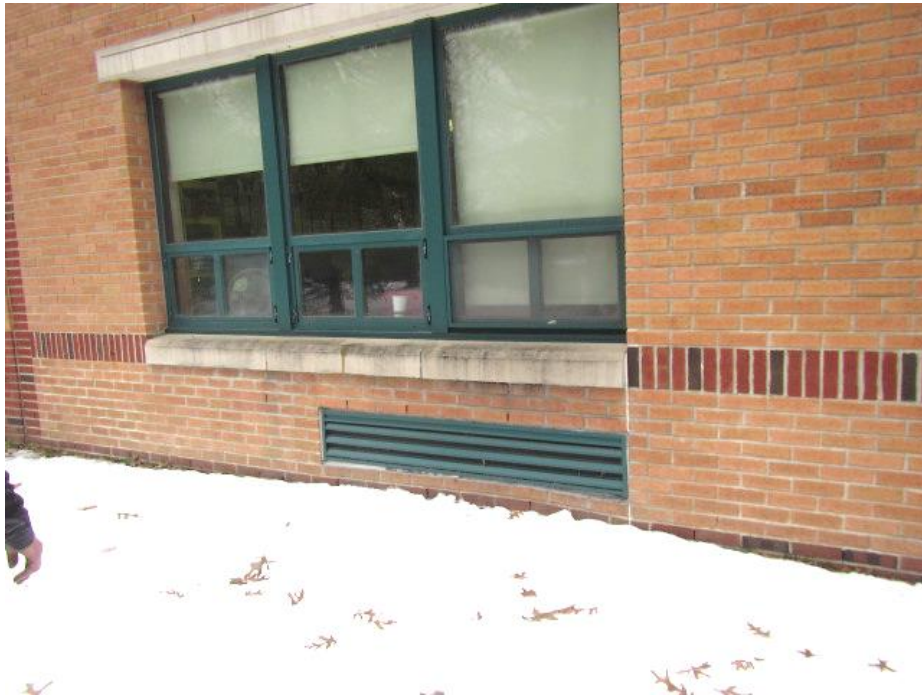
Picture 3

Another potential source of odors and allergens is grass/plant debris lodged in univent fresh air intakes when grass is mowed. The design of the metal intakes makes them conducive to collecting debris (Picture 3), which if, wetted repeatedly, can become moldy and be a source of

irritation and odors. During lawn mowing, debris should be aimed *away* from intakes. In addition, intakes should be inspected/cleaned out periodically as needed.

Univent fresh air intake

20. During lawn mowing, aim debris *away* from air intakes. In addition, inspect/clean intakes of debris periodically as needed.
21. Reduce or eliminate the use of air fresheners/diffusers, scented cleaners, hand sanitizers and dry erase materials to reduce irritation. Consult the MDPH IAQ Guidance “Clean Air is Odor Free”, <https://www.mass.gov/lists/indoor-air-quality-guidelines> for more information. In addition, spray bottles/cleaning products should be *kept out of reach of children*.

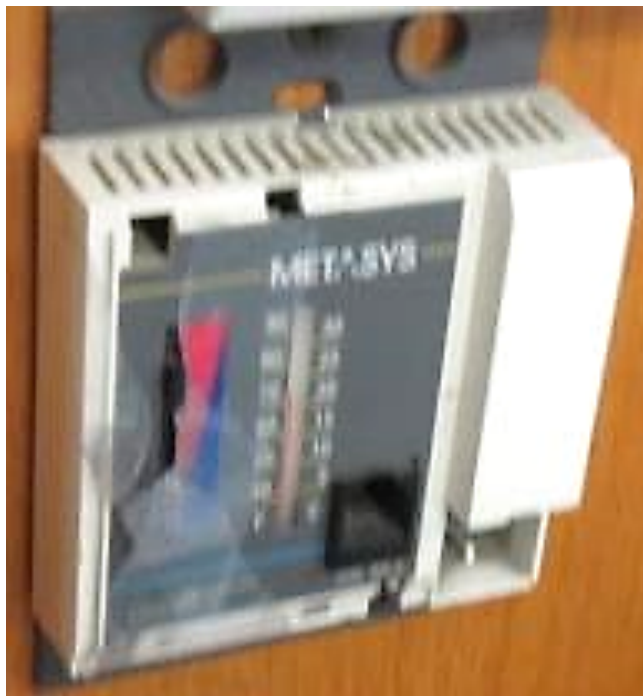
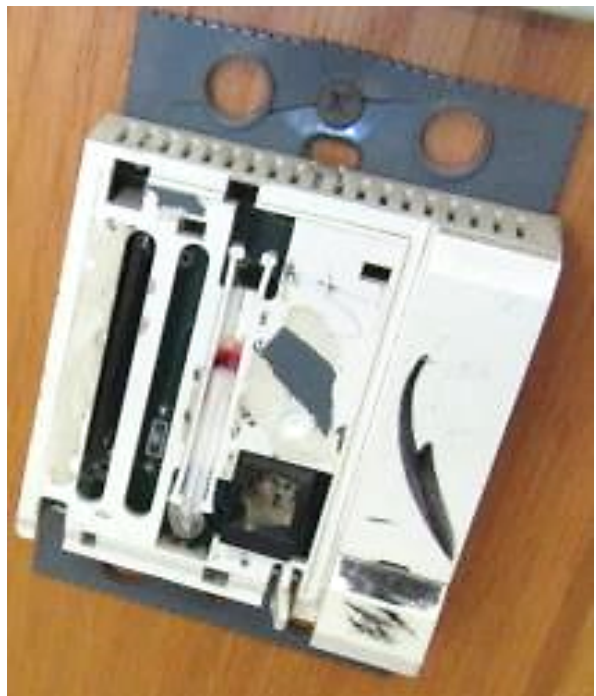
Pictures 4a and 4b

- **Temperature** measurements were both above and below the MDPH recommended range of 70°F to 78°F in a number of areas, mostly related to mechanical ventilation/thermostat control issues. It is important to note that many of the classroom thermostats were broken/in a state of disrepair.

Severely damaged/inoperable classroom thermostats

7. Close classroom doors during occupancy to allow for more effective function of exhaust vents (once operating as designed).
8. Work with staff to troubleshoot temperature control/ventilation problems.

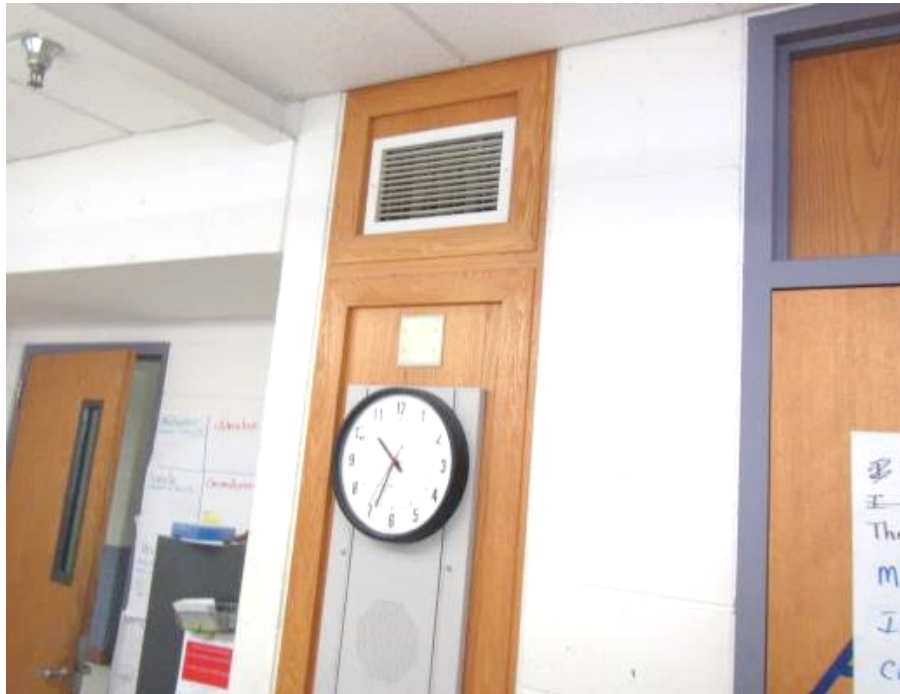
Picture 5

Classroom exhaust vents are located in walls (Picture 5) or ceilings (Picture 6) and are connected via ducts to exhaust fans on the roof. A number of these exhaust vents were not drawing air during the assessment (Table 1). Note that exhaust vents work best with the doors to the hallway closed, otherwise the exhaust vents tend to draw air from the hallway rather than the room which reduces the effectiveness of air circulation. Without adequate supply and exhaust ventilation, excess heat/humidity and environmental pollutants can build up and lead to indoor air/comfort complaints.

Wall-mounted exhaust vent

5. Periodically assess whether exhaust vents (classrooms and restrooms) are drawing air and make repairs as needed.
6. Use openable windows to supplement fresh air during temperate weather. Ensure all windows are closed tightly at the end of each day.

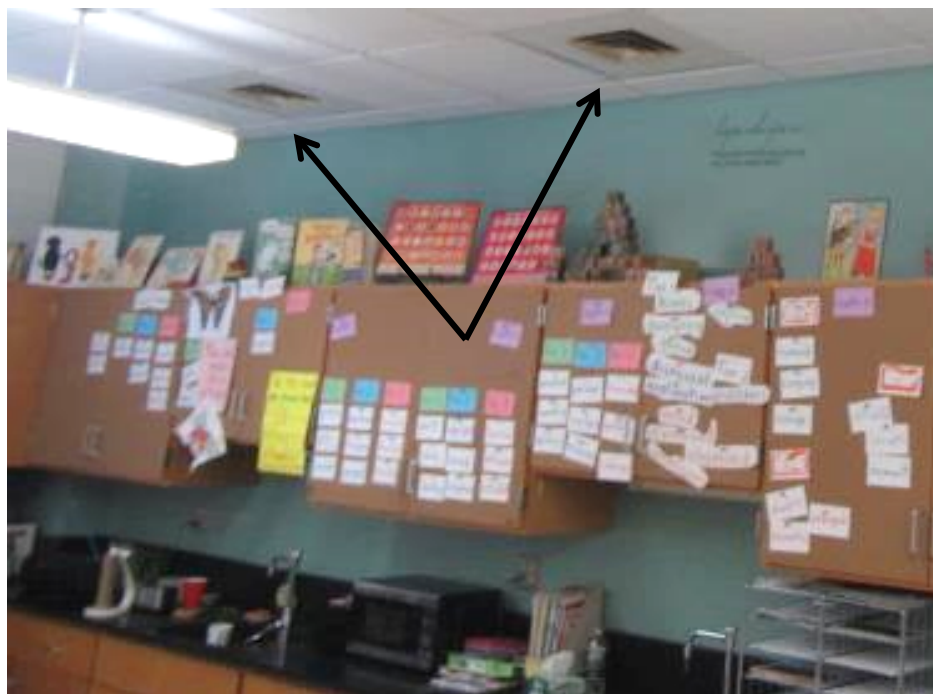
Picture 6

Ceiling-mounted exhaust vents (arrows)

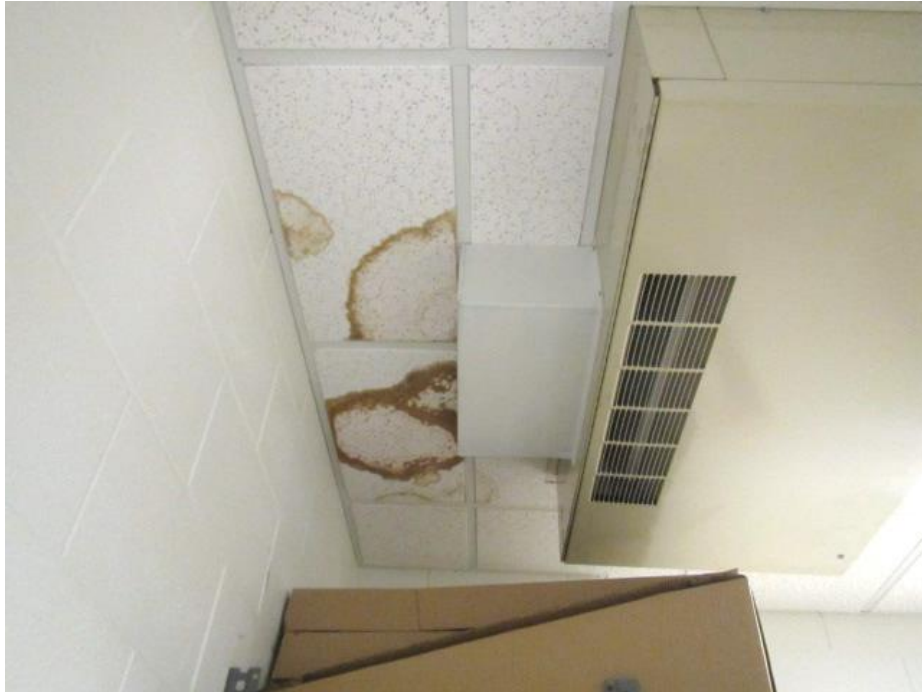
Picture 7

- Ceiling tiles – Pictures 7 and 8, water-stained ceiling tiles can indicate current/historic roof/plumbing leaks or other water infiltration. As active leaks are reported, the facilities department works with a local roof contractor to investigate and repair. Water-damaged ceiling tiles can provide a source of mold and should be replaced after a water leak is discovered and repaired;
- Gypsum wallboard (GW) - water-damaged GW ceilings were noted in a number of areas (Pictures 9 through 11), most in areas where roof leaks have reportedly been repaired. MDPH/IAQ Program staff conducted moisture measurements of water-damaged GW in a number of areas and all were found dry at the time of the assessment, with the exception of room 105 (Picture 12). It was recommended that this GW be removed/replaced.

Water-damaged ceiling tiles

11. Until capital funds can be obtained for full roof replacement, continue to work with roofing contractor to identify and repair leaks.
12. Once roof leaks are repaired, replace water-damaged ceiling tiles and refinish areas where water damage has occurred. Inspect the area above the stained tiles for water damage or odors and remediate or clean as necessary.

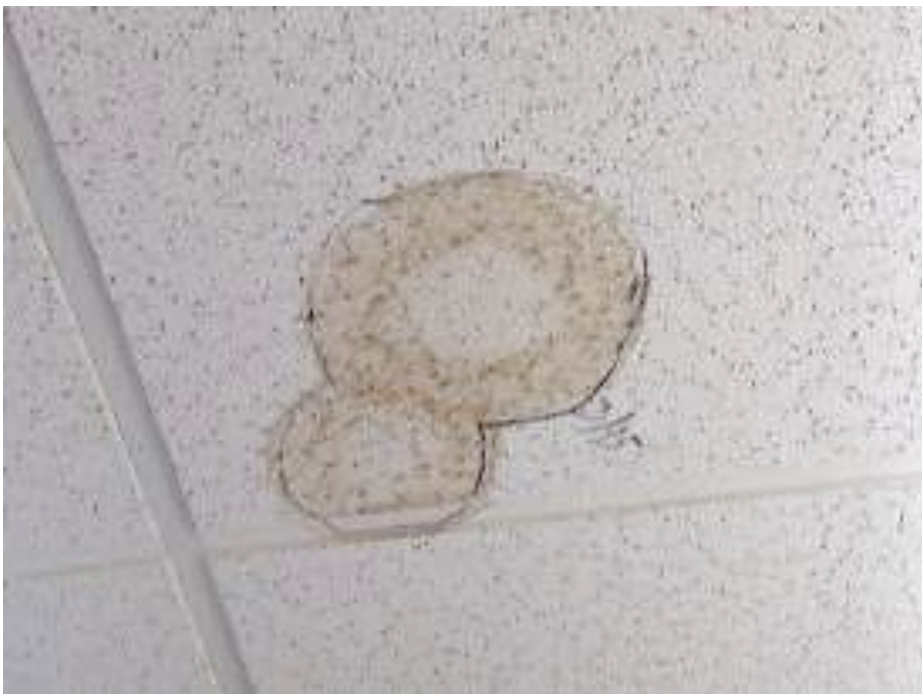
Picture 8

Water-damaged ceiling tiles, note outline around stain dated “3/15”

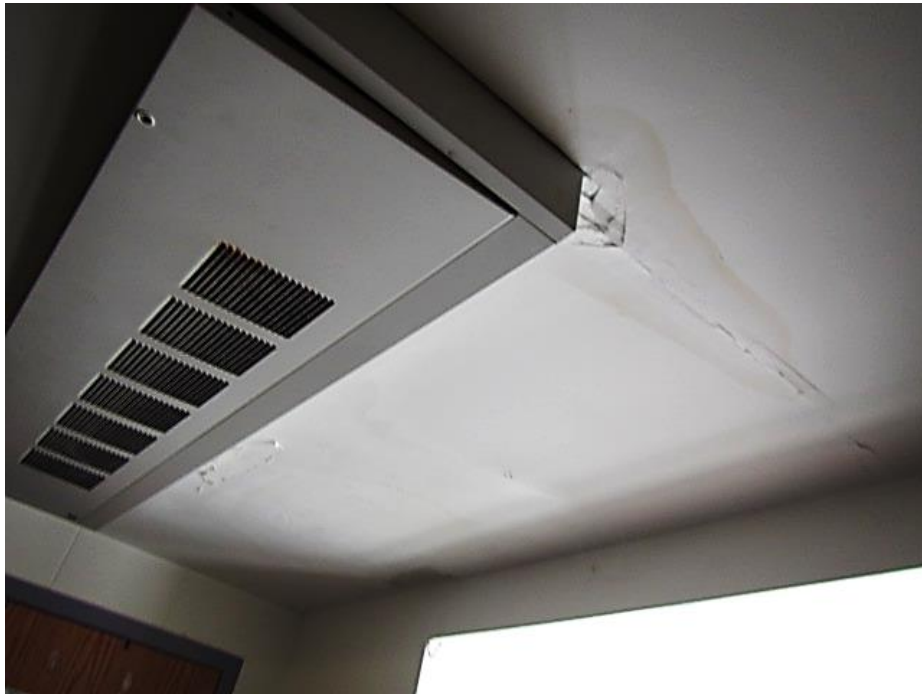
Picture 9

Water-damaged gypsum wallboard ceiling in Room 105 that was wet at the time of the visit

13. Remove and replace wet/water-damaged GW in Room 105.
14. Continue to investigate source of musty odors in rooms 305, 307 and 301 hallway. Consider working with roofing contractor/building engineer, plumbing firm to investigate possible sources of odors, this may include but not limited to:

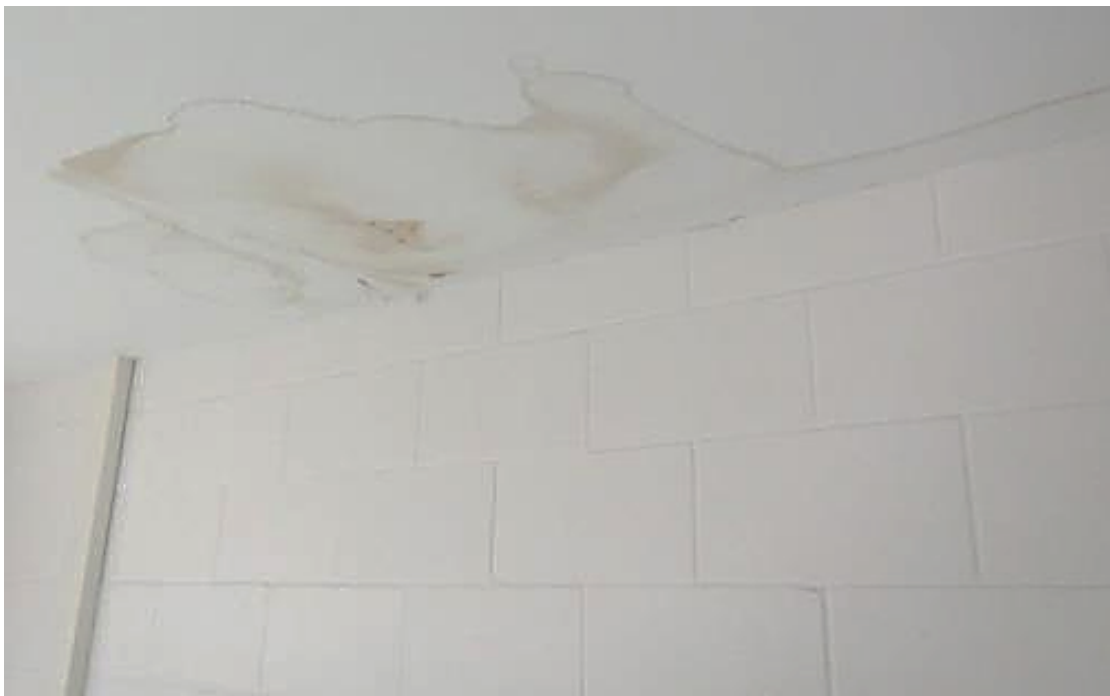
Picture 10

Mechanical ventilation in common areas (cafeteria, media center, gym) and interior rooms is provided by air handling units (AHUs) located on the roof or in mechanical rooms. Air is drawn in through air intakes, filtered, heated/cooled and distributed via ceiling or wall-mounted diffusers. Air is drawn back to AHUs via ceiling or wall-mounted return vents. Room 282, which is windowless, currently has no working mechanical ventilation. A source of fresh/outside air should be restored in this area, if possible, either from the roof or from the adjacent Media Center.

Water-damaged gypsum wallboard ceiling in Room 282 (adjacent to Media Center)

1. Contact an HVAC engineering firm for an assessment of the ventilation system's components and control systems (e.g., pneumatics/air intake louvers, thermostats). Based on the age, physical deterioration, and availability of parts for ventilation components, such an evaluation is necessary to determine the operability and feasibility of repairing/replacing the equipment.
2. Consider full roof replacement.
3. Install local exhaust ventilation for photocopiers in Teacher's workroom.
4. Replace mechanical ventilation unit in Room 282 and ensure unit provides adequate outside air exchange.

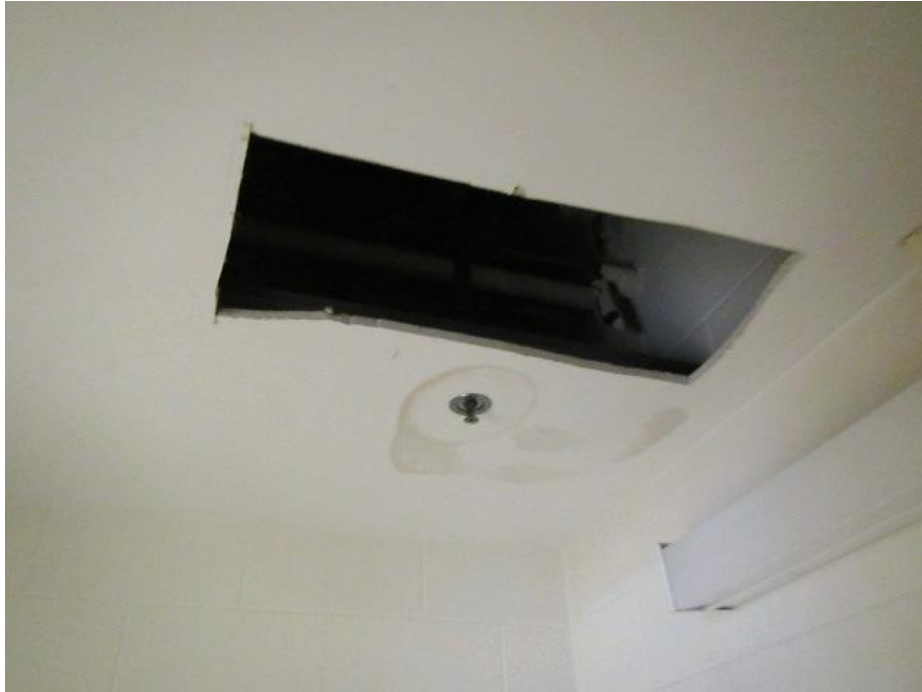
Picture 11

Water-damaged gypsum wallboard ceiling in men's restroom near 301

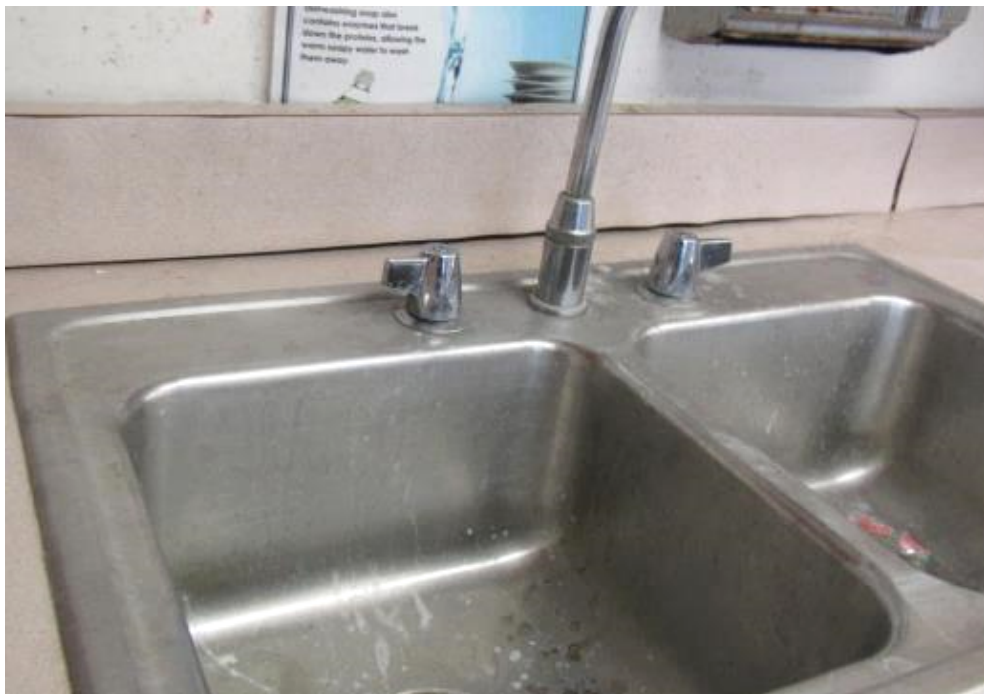
Picture 12

- The sink/countertop in room 201A was warped and had a gap between the backsplash and countertop, which can lead to further water damage and microbial growth (Picture 12).

Water-damaged countertop and backsplash in Room 201A

18. Make repairs to sink countertop in room 201A and any others in need of caulking/re-sealing.
19. Run water in sinks regularly to avoid dry drain traps and associated odors, if not feasible consider decommissioning/capping.

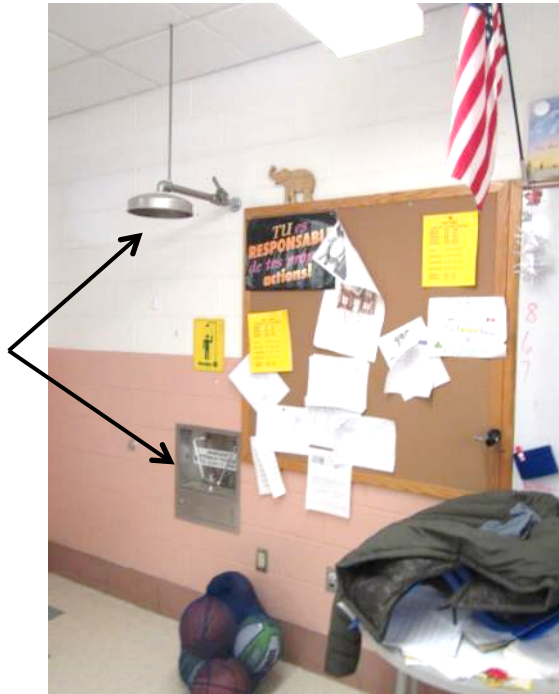
Picture 13

Musty odors of unknown origin were reported/detected in three areas: Room 305, Room 307, and the hallway outside Room 301. There were no obvious signs of water damage/leaks or visible mold growth in these areas. The two rooms are former science rooms with little used/abandoned fixtures that could be a potential source of moisture/odors including: emergency eye wash stations/showers (Picture 13), numerous sinks (Picture 14), and auxiliary exhaust units in the ceiling (used during science experiments, Picture 6). The seal of traps on sink drains that are not used often can dry out and allow sewer gases into occupied areas, which may account for the reported odors. Water damage may also have occurred in areas such as behind univents, above ceilings and beneath wooden windowsills (Pictures 15 and 16). Each of these building components should be examined to rule out sources of the odor, and, if needed, be repaired.

In addition, all areas with drains (e.g. eyewash stations, safety showers and classroom sinks) should be evaluated periodically for proper function. These fixtures should be properly removed or abandoned if no longer needed.

Emergency eye wash station and shower (arrows) in former science classroom

- a. Dry drain traps;
 - b. Disused plumbing and/or components unique to former science classrooms (e.g., auxiliary ventilation, eye wash stations, emergency showers;

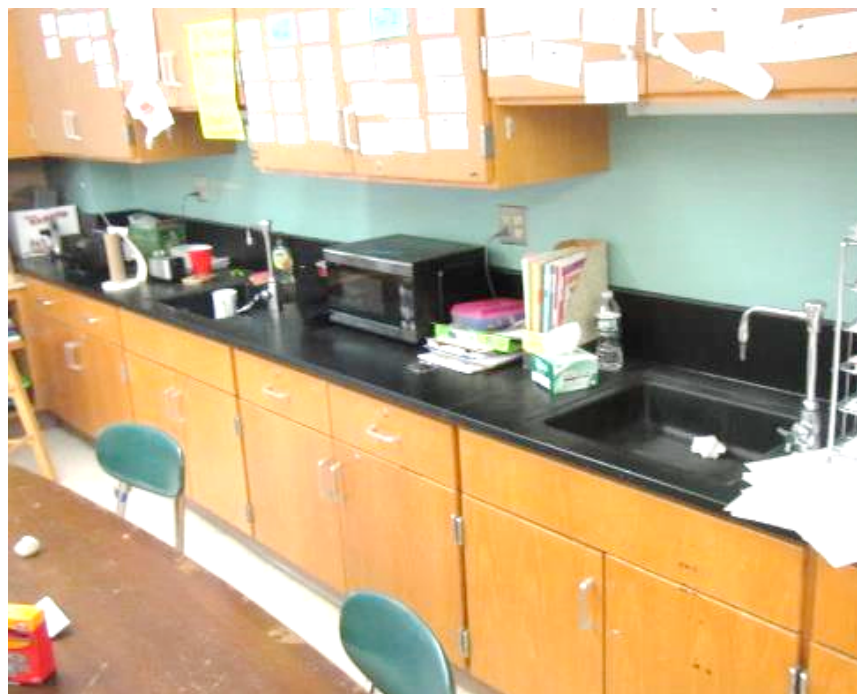
Picture 14

Sinks in former science room

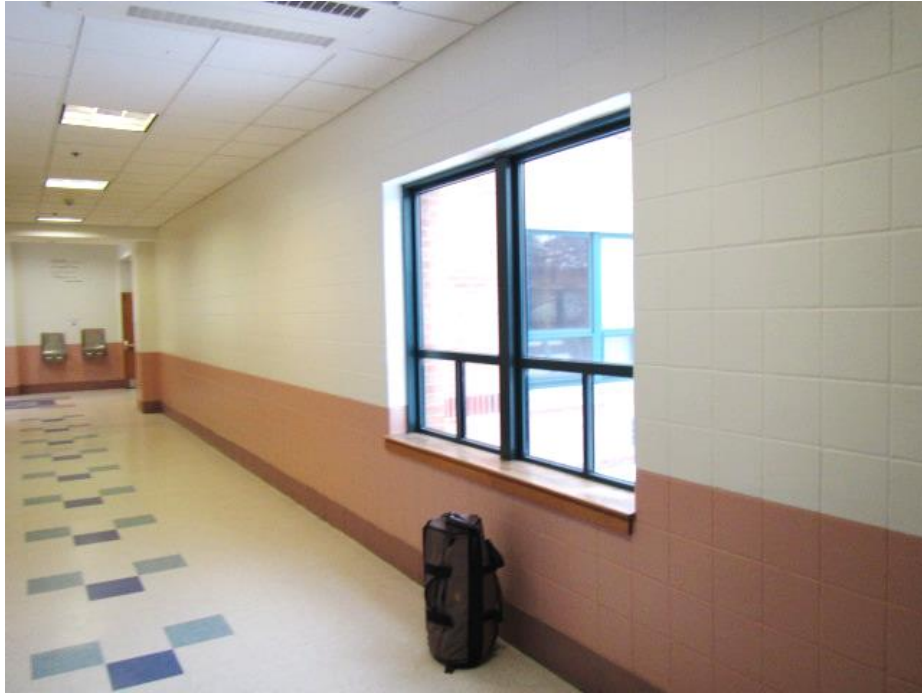
Picture 15

Wooden windowsill in Hallway outside Room 301

- c. Water-damaged materials such as ceiling tiles and wooden windowsills. Examine areas to rule out hidden damage building envelope leaks (e.g., fenestrations, exterior flashing, roof/drainage, weep holes);

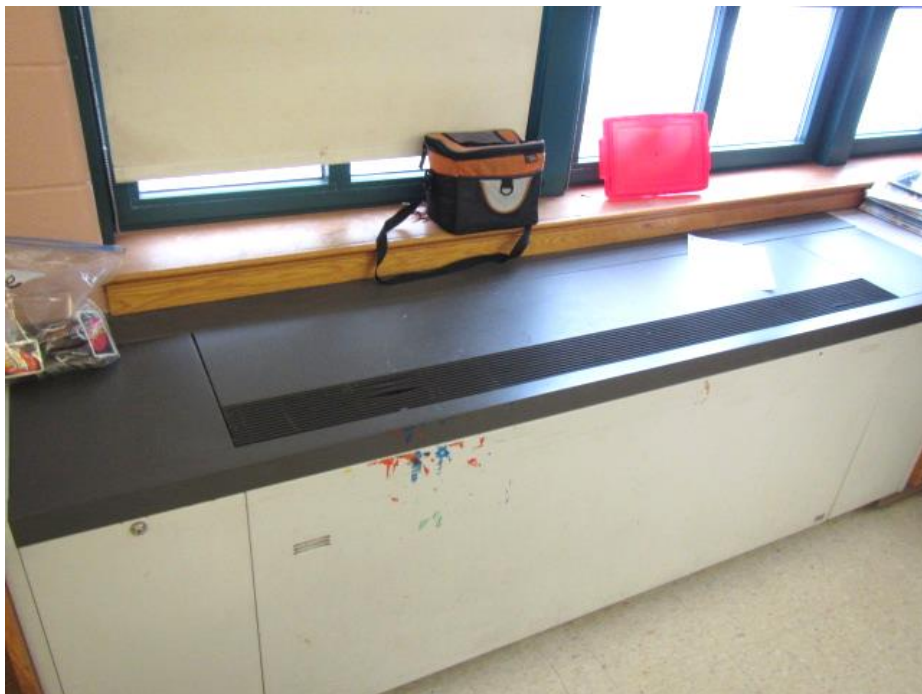
Picture 16

Univent and wooden windowsill in Room 305

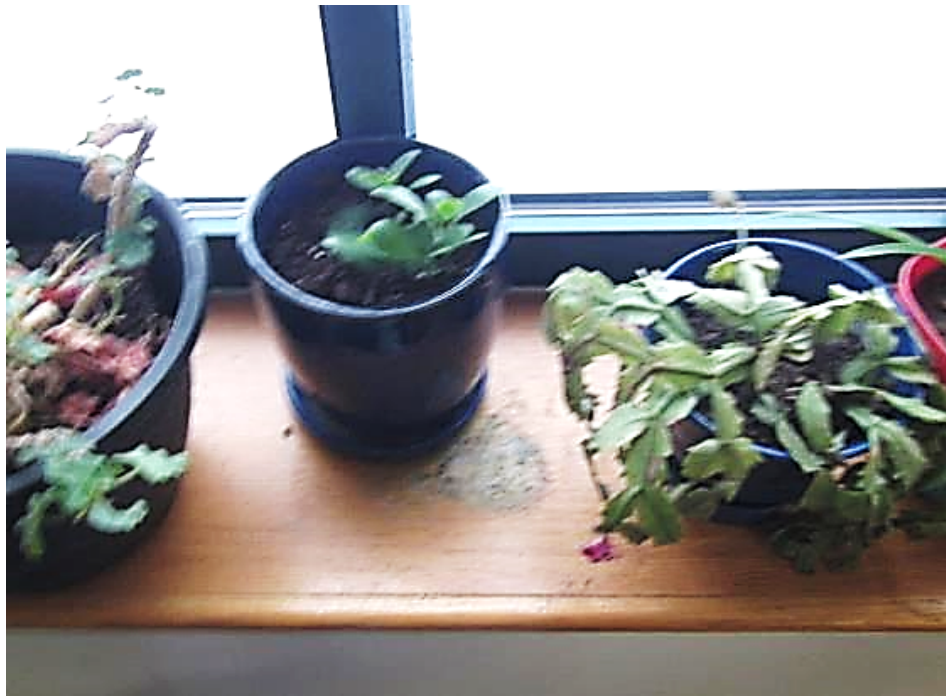
Picture 17

Plants were present in some classrooms and other areas. Plants, soil, and drip pans can serve as sources of mold/bacterial growth. Plants should be properly maintained, over-watering of plants should be avoided (Picture 17), and drip pans should be inspected periodically for mold growth. In addition, plants should not be placed on top of or in the airstream of HVAC equipment such as univents.

Plants and water-damaged wooden windowsill

16. Keep classroom/office plants in good condition, avoid overwatering, and keep them away from the airstream of ventilation equipment.
17. Ensure aquariums and terrariums are clean and odor free.

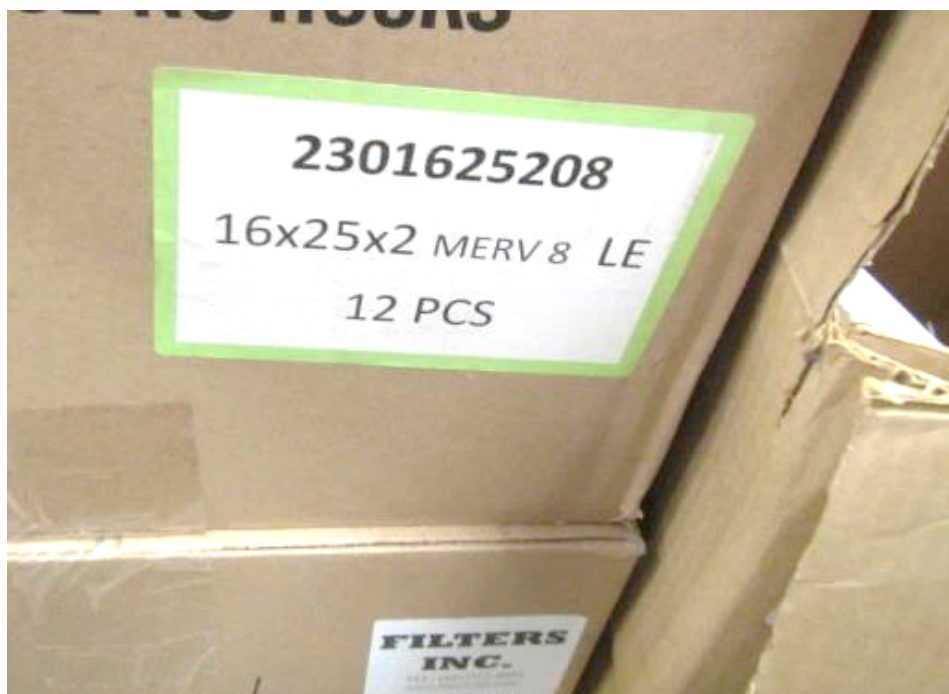
Picture 18

Other conditions that can affect indoor air quality were observed during the assessment. The MDPH recommends pleated filters with a Minimum Efficiency Reporting Value (MERV) of 8, which are adequate in filtering out pollen and mold spores (ASHRAE, 2012). Filters should also be changed two to four times a year, or per the manufacturer's recommendations. The AHU filters were labeled MERV 8 (Picture 18); filters for univents were labeled "pleated" with no MERV rating (Picture 19).

Box indicating MERV 8 filters

22. Change filters in HVAC units 2-4 times a year with MERV 8 (or higher) filters.
23. Clean supply/exhaust vents, univents (e.g., Room 206) and personal fans regularly to remove accumulated dust/debris.

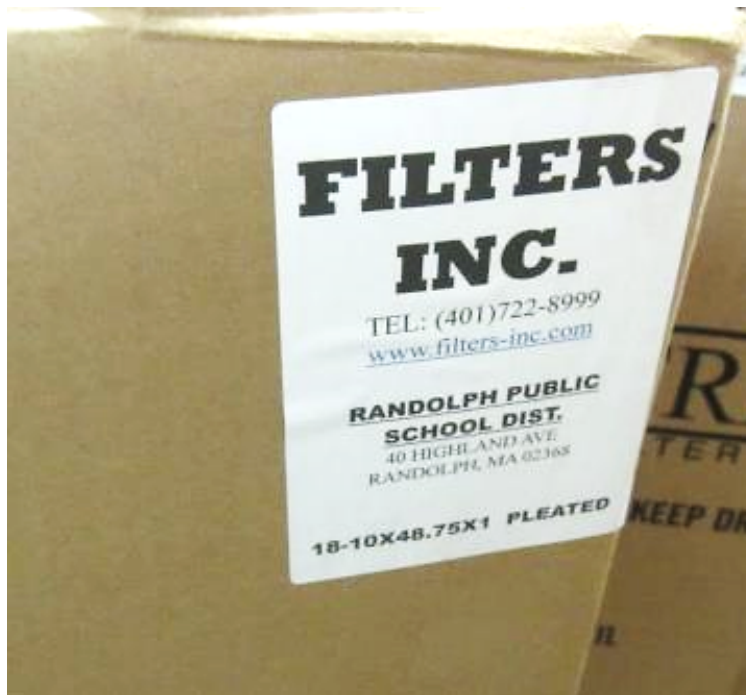
Picture 19

Label indicating “PLEATED” filters with no MERV rating

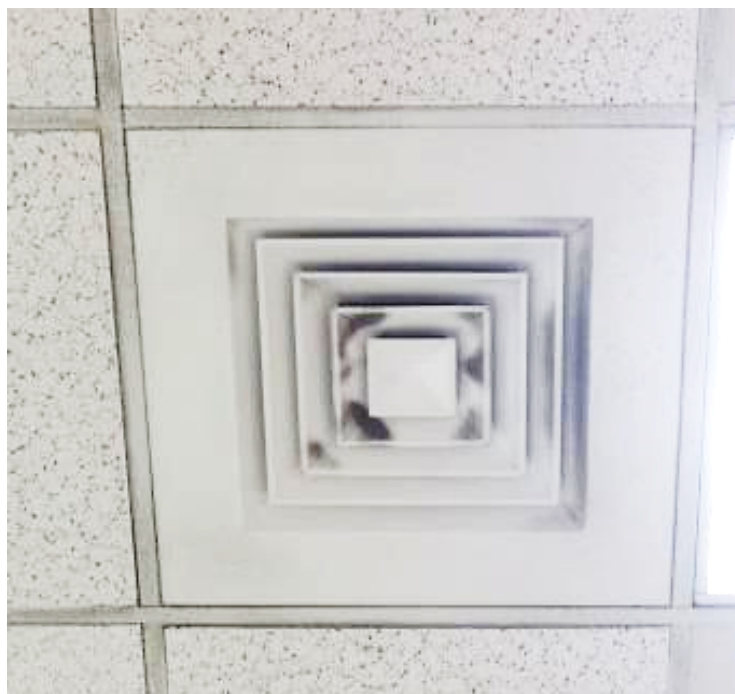
Picture 20

In some areas, exhaust vents, supply diffusers and personal fans had accumulated dust/debris (Table 1, Picture 20). This dust can be reaerosolized under certain conditions, and can also be a medium for mold growth. Univent and AHU cabinets can also accumulate dust and debris which should be cleaned when filters are changed (e.g., 2 to 4 times/year). The occupant in Room 206 reported dust/debris from the ceiling-mounted unit. Univents also typically have an insulation material adhered to the cabinet cover to reduce sound (Picture 21); this material can break down eventually and become a source of debris.

Accumulated dust/debris on supply diffuser

28. Clean supply/exhaust vents and personal fans regularly to remove accumulated dust/debris.

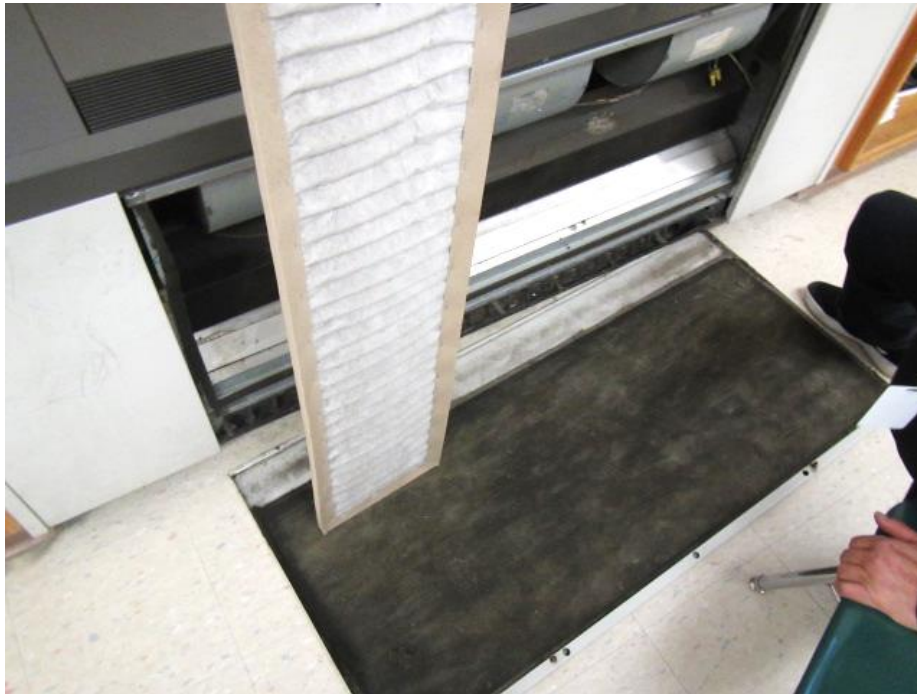
Picture 21

Pleated univalent filter, also note insulation material on interior of cabinet cover

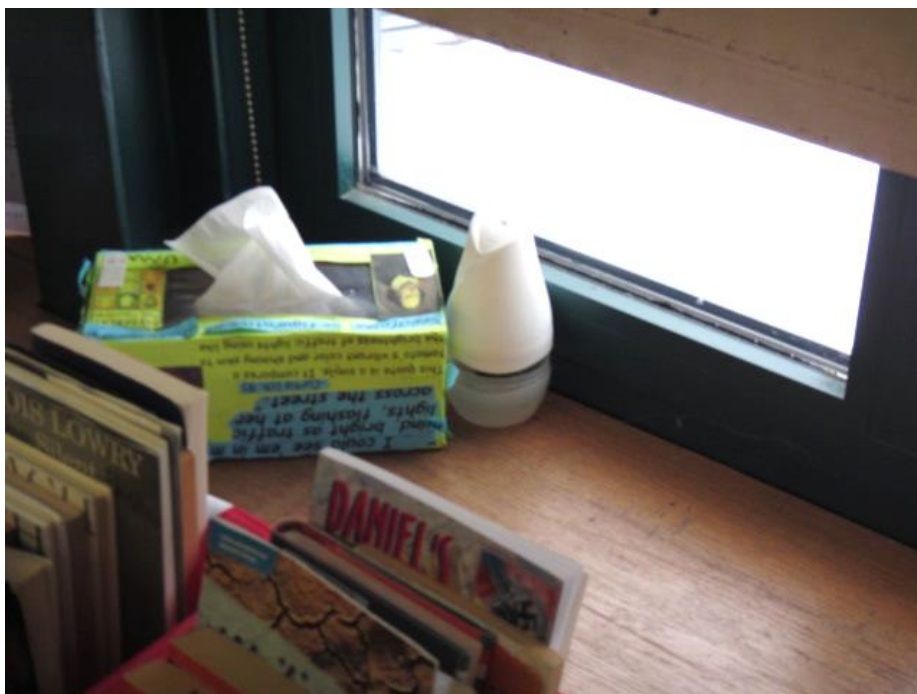
Picture 22

Exposure to low levels of total volatile organic compounds (TVOCs) may produce eye, nose, throat, and/or respiratory irritation in some sensitive individuals. BEH/IAQ staff examined rooms for products containing VOCs. BEH/IAQ staff noted hand sanitizers, scented products, plug in air fresheners/diffusers (Pictures 22 and 23), home cleaning products, and dry erase materials in use within the building. All of these products have the potential to be irritants to the eyes, nose, throat, and respiratory system of sensitive individuals.

Air freshener in classroom

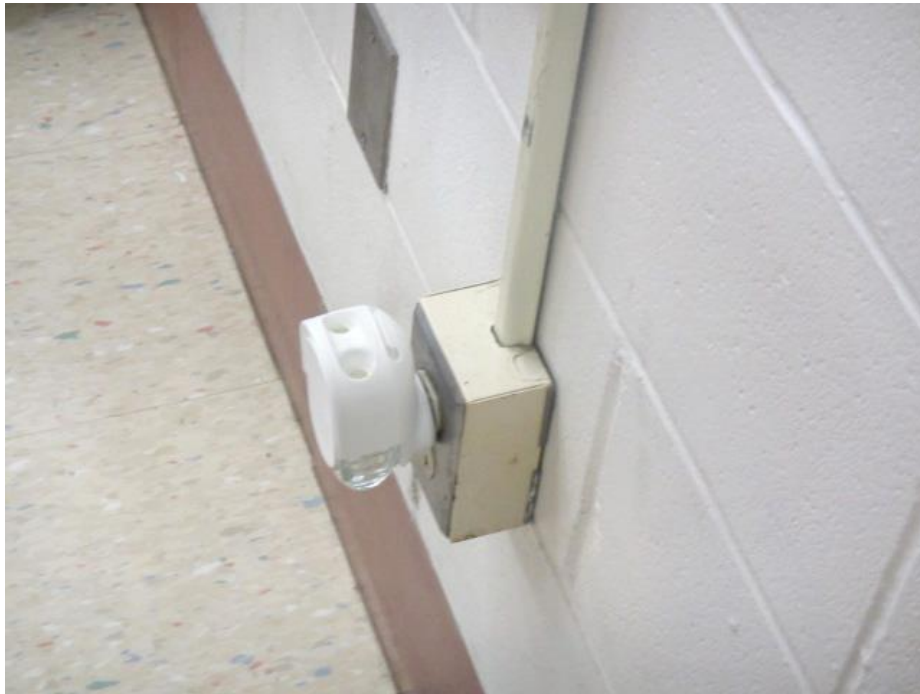
Picture 23

Plug-in air freshener in classroom

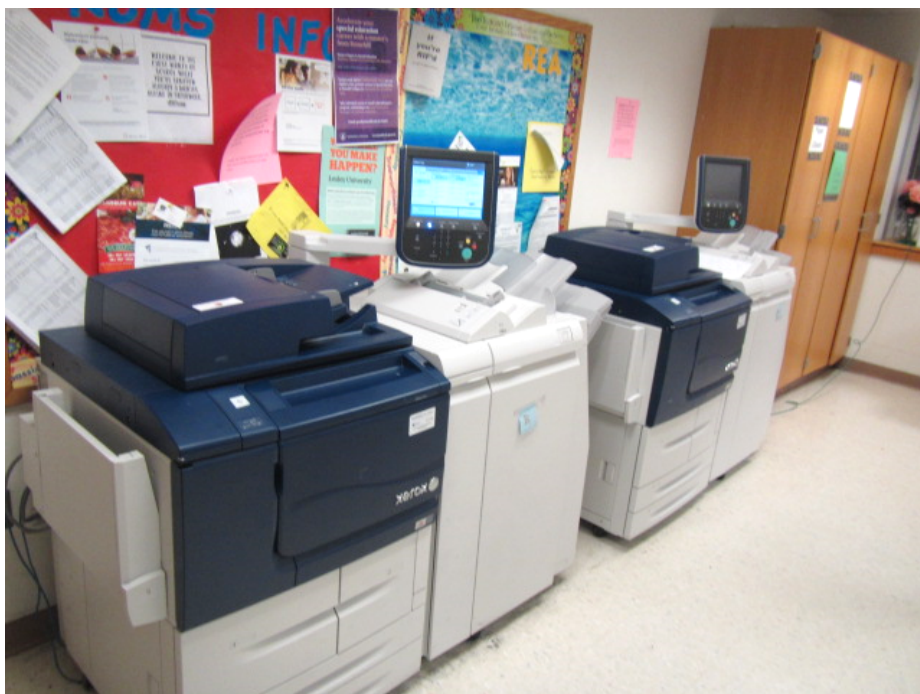
Picture 24

The Teacher's workroom contained two large photocopiers (Picture 24), which can give off waste heat and irritating odors. VOCs and ozone can be produced by photocopiers, particularly if the equipment is older and in frequent use. Ozone is a respiratory irritant (Schmidt Etkin, D., 1992).

Two large photocopiers in Teacher's Workroom
